**BLACKSTONE RIVER BASIN
WORCESTER, MASSACHUSETTS**

**GREEN HILL POND DAM
MA 00149**

**PHASE I INSPECTION REPORT
NATIONAL DAM INSPECTION PROGRAM**

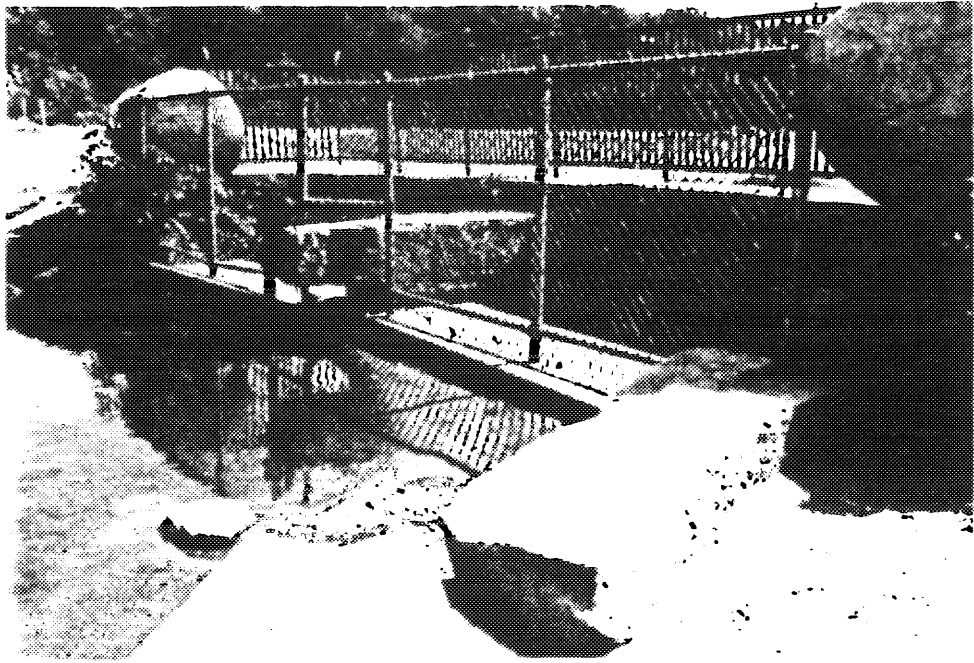
- c. Appurtenant Structures. The spillway is a vertical stone shaft with a granite overflow weir. The structure is in poor condition. Water is flowing under the granite weir and into the shaft. The piece of granite on the west half of the weir is misaligned. The shaft is filled with soil and debris to within 2 feet of the crest of the weir. This obstruction restricts all flows over the spillway. There is a fence located upstream of the crest of the spillway.

NO. 1 VIEW OF SPILLWAY

- (3) construct a gated outlet
- (4) repair the weir of the spillway where water is flowing beneath the granite slabs and realign the western weir stone.

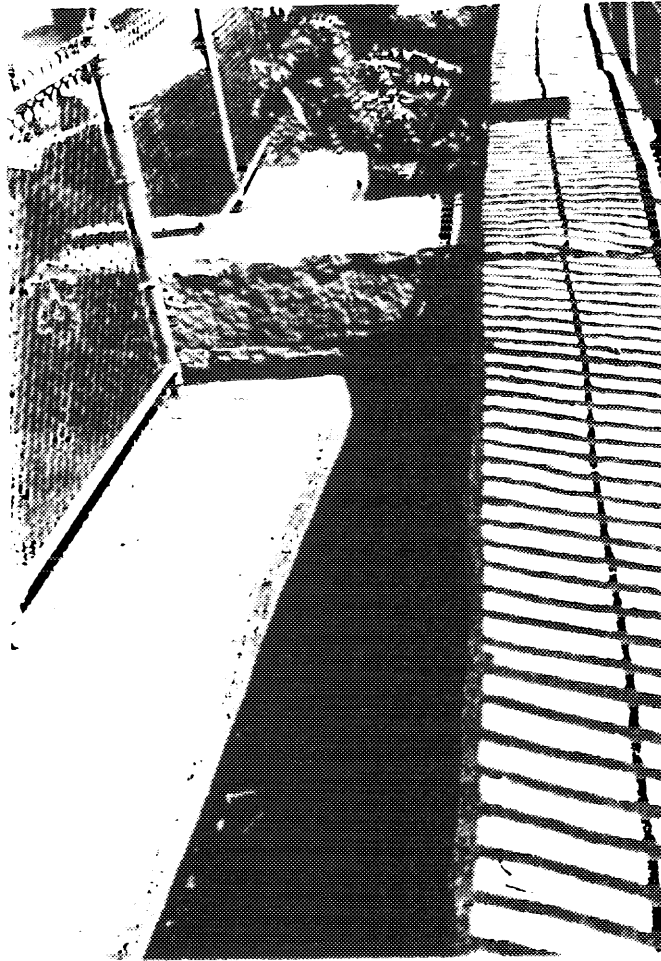
c. Discharge Channel	vertical drop shaft - ^{mortared} stone walls
General Condition	very poor - filled with soil + trash to within 2 ft of crest
Loose Rock Overhanging Channel	loose slab on weir
Trees Overhanging Channel	none
Floor of Channel	not visible
Other Obstructions	none

NO. 2 VIEW OF DEBRIS IN SPILLWAY

- (1) remove all debris from the shaft of the spillway and the overflow diversion facilities
- (2) install a trash rack on the spillway and repair the trash rack on the overflow diversion

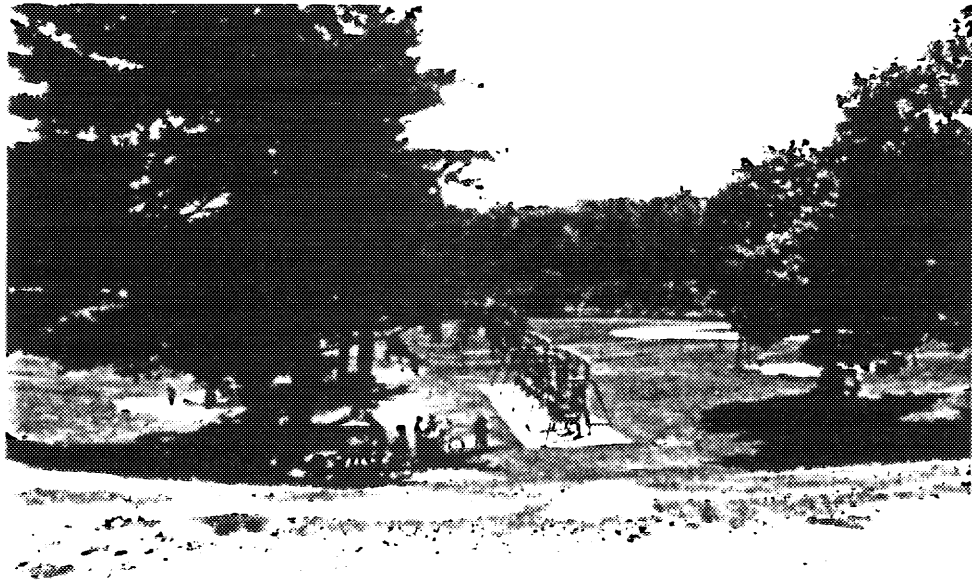
- b. Dam. Green Hill dam is an earth fill embankment with a stone masonry core wall. The dam is generally in good condition. No seepage was noted at the dam. The slopes of the dam are flat and clear of trees. The crest is mostly a paved roadway. Two signs of distress were observed at the site. First, erosion has occurred on the upstream face of the dam near the west abutment. Sand has been washed away around the concrete slabs in the picnic areas. The slabs are cracked and settled. There are no signs of riprap protection on the upstream face of the dam. Secondly, surface runoff from Green Hill Parkway, which collects near the midpoint of the dam, has eroded a gully in the downstream face. This runoff combines with runoff from the hillside east of the dam and forms large puddles of water in the playground area downstream of the toe of the dam.

NO. 3 VIEW OF DOWNSTREAM DAM SLOPE

- (8) construct a swale such that surface runoff from the downstream side slopes does not collect and form wet areas below the toe of the dam
- (9) repair the concrete on the intake of the diversion conduit

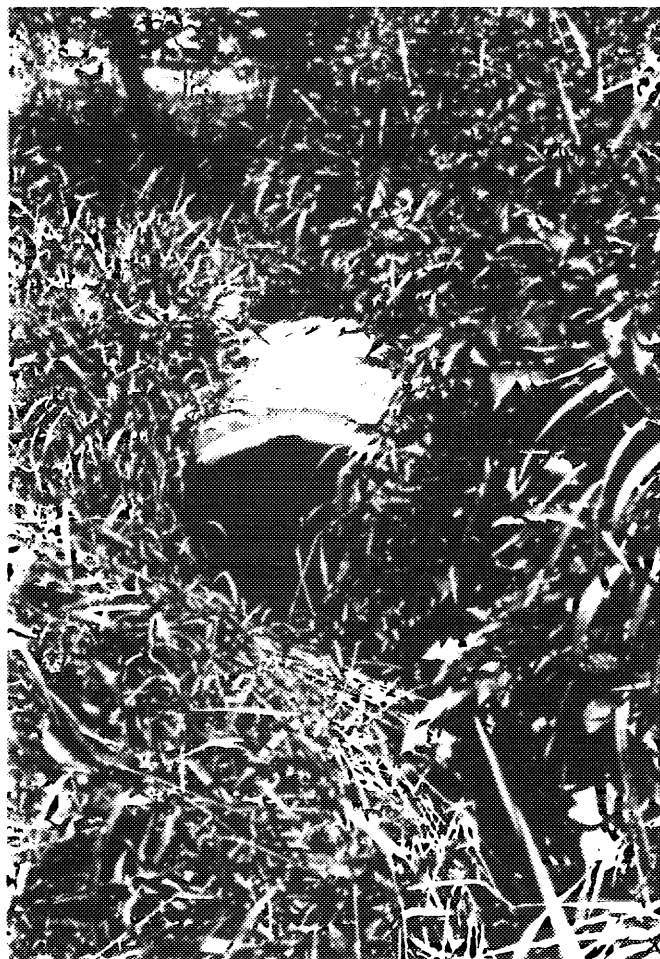
The outlet conduit extends 573 feet from the upstream face of the shaft of the spillway to the outlet. The upstream approach area appears to be completely filled with sand. The condition of 121 feet of the conduit under the dam is unknown. Sediment has accumulated to a depth of 0.5 feet at the bottom of the first manhole located 121 feet downstream. The conduit appears to be blocked between the first and second manholes. The outlet end of the conduit contains a build-up of sediment 0.9 feet thick at the invert of the pipe.

- 4.3 Maintenance of Operational Facilities. Only the downstream end of the outlet conduit was visible during inspection. The end of the pipe is filled in with silt to a depth of 0.9 feet. The condition of the intake was not visible, since it is apparently plugged. The overflow diversion is plugged with leaves, wood, and trash.

NO. 4 VIEW OF OUTLET CONDUIT

- (5) clean accumulated silt out of the man-holes and outlet conduits
- (6) repair erosion on the upstream face of the dam and protect the slope with riprap
